TOWN OF PLYMOUTH, NEW HAMPSHIRE

PLYMOUTH FIRE & RESCUE FACILITY CONDITIONS ASSESSMENT

AUGUST 8, 2023

TTG PROJECT No. 5428

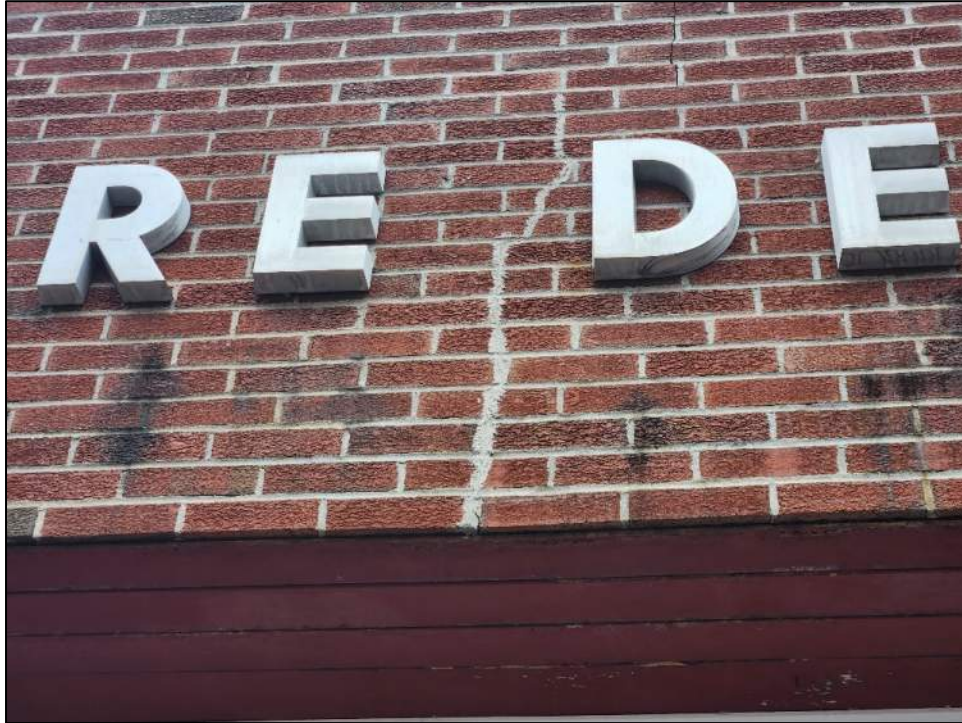
The parapet wall/roof connection is currently utilizing a termination bar. Typically, a termination bar is not used in a horizontal application, but in a vertical application. There is a crack in the brick veneer on the front wall in the parapet wall.

Crack in Brick Veneer.

The front wall which consists of masonry (CMU with a brick veneer) is in good condition except for the crack above one of the overhead doors. The lower section of the crack has been sealed, but the crack now extends up to the top of the parapet wall. At a minimum, the crack should be completely sealed to prevent any moisture from getting into the wall.

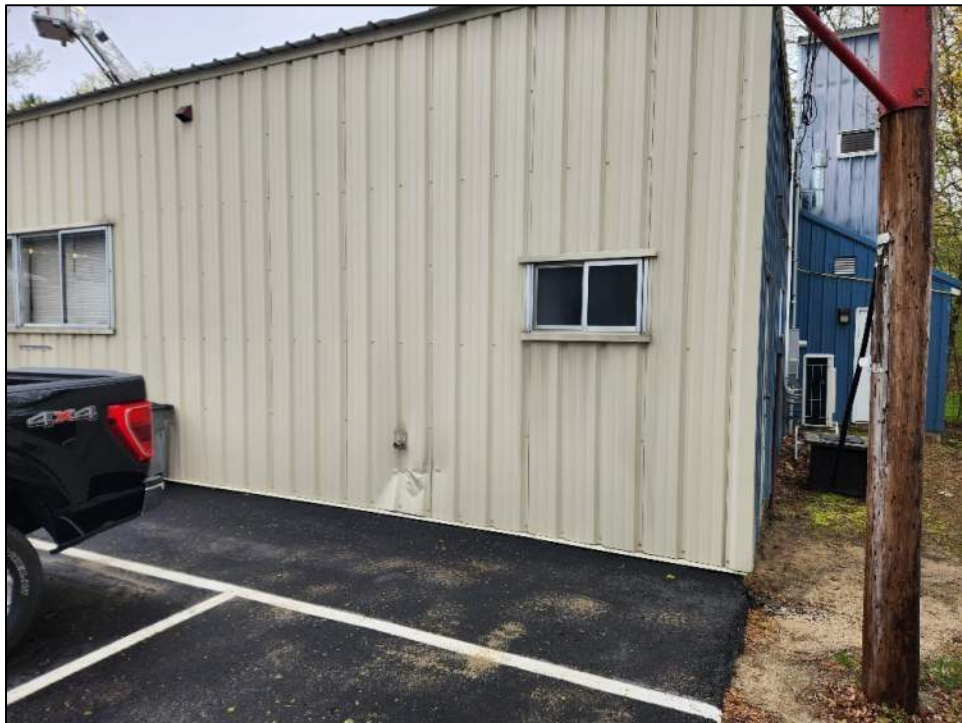
The metal siding, especially on the parking lot side, has several dents. It was also noted that the siding and siding fasteners are rusting. A number of patches to the metal siding on the north side of the apparatus bay have been made.

Dented Metal Siding.

The remaining exterior walls are clad with metal siding. The siding is in need of replacement.

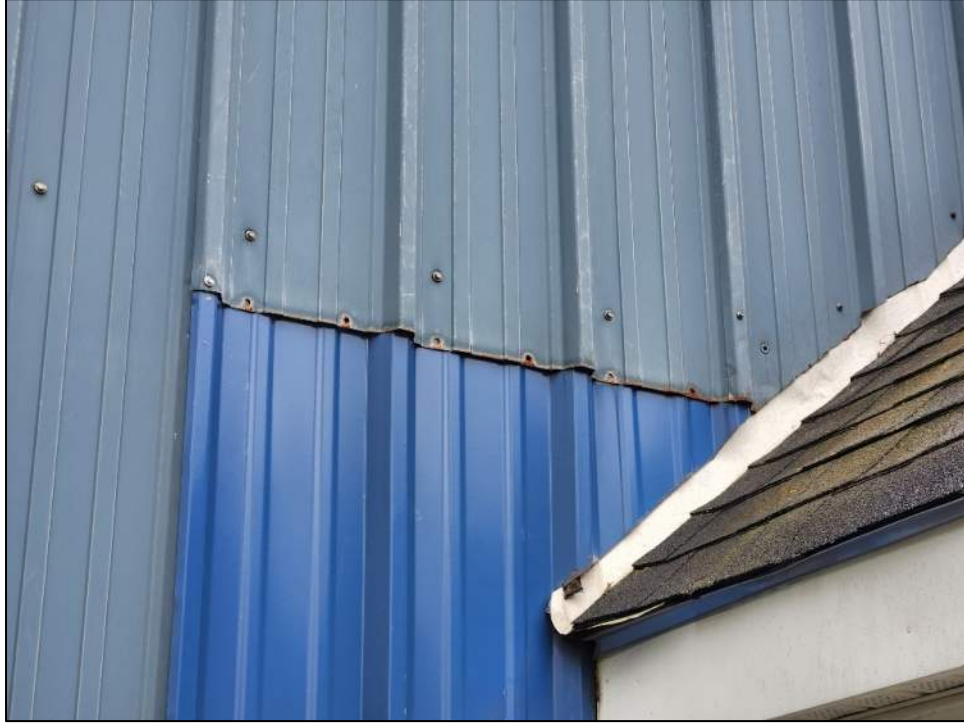
Patch in the Metal Siding.

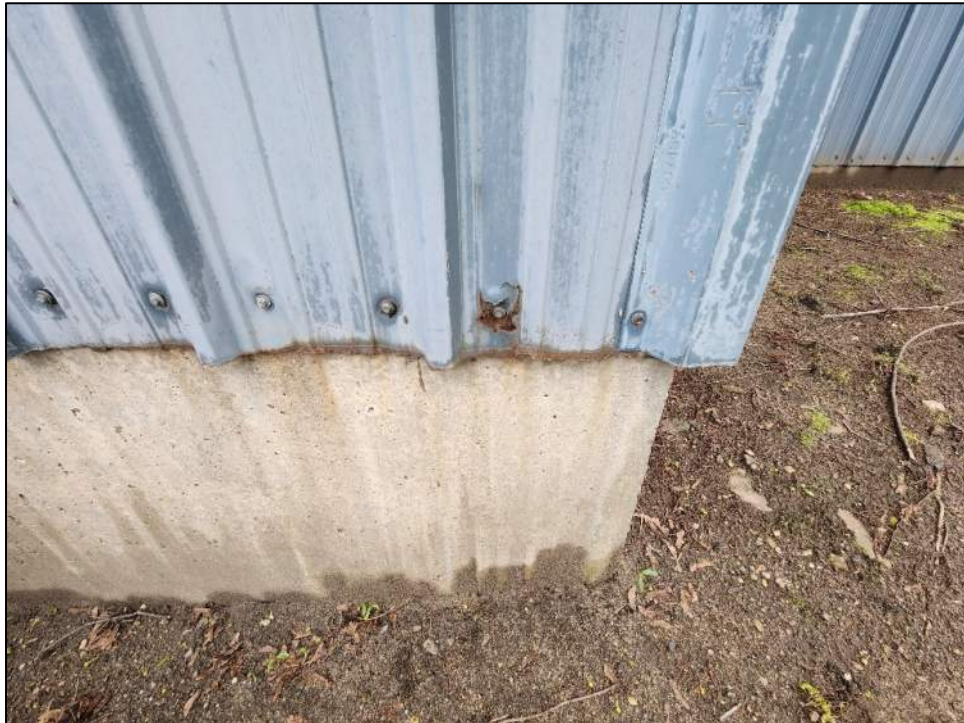
Rusting Metal Siding and Fasteners.

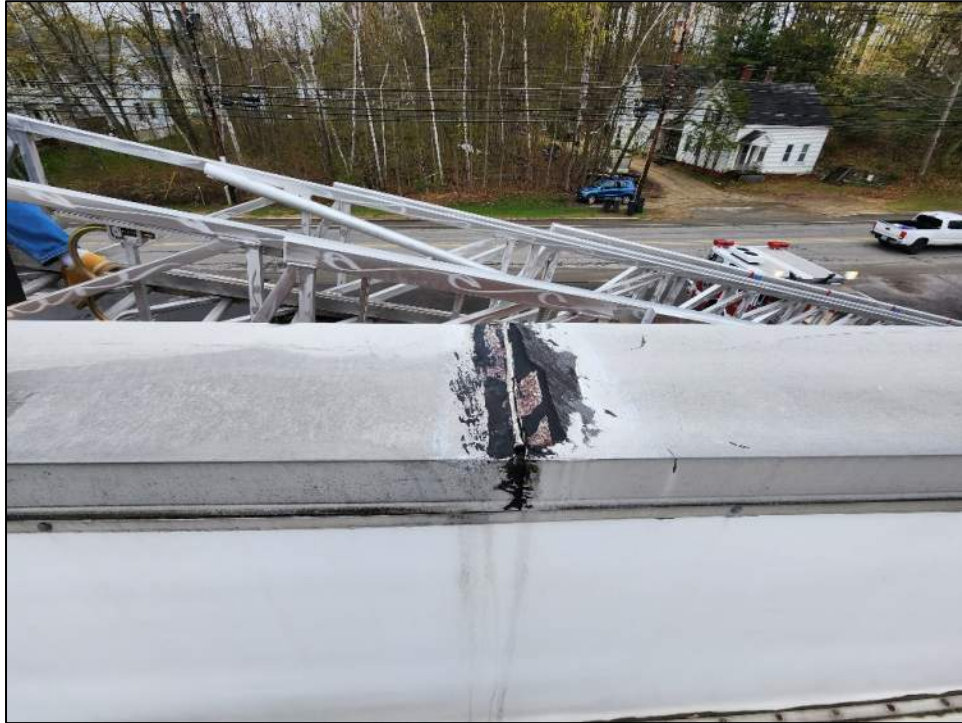
Sealant Joint at Top of Parapet Wall.

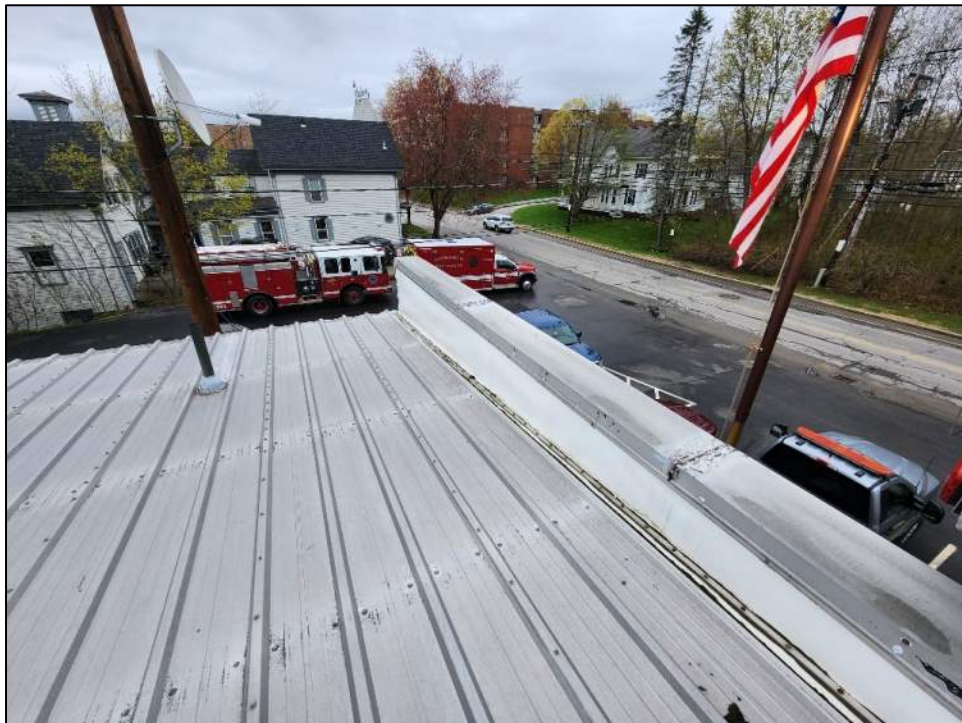
Termination Bar at Parapet Wall.

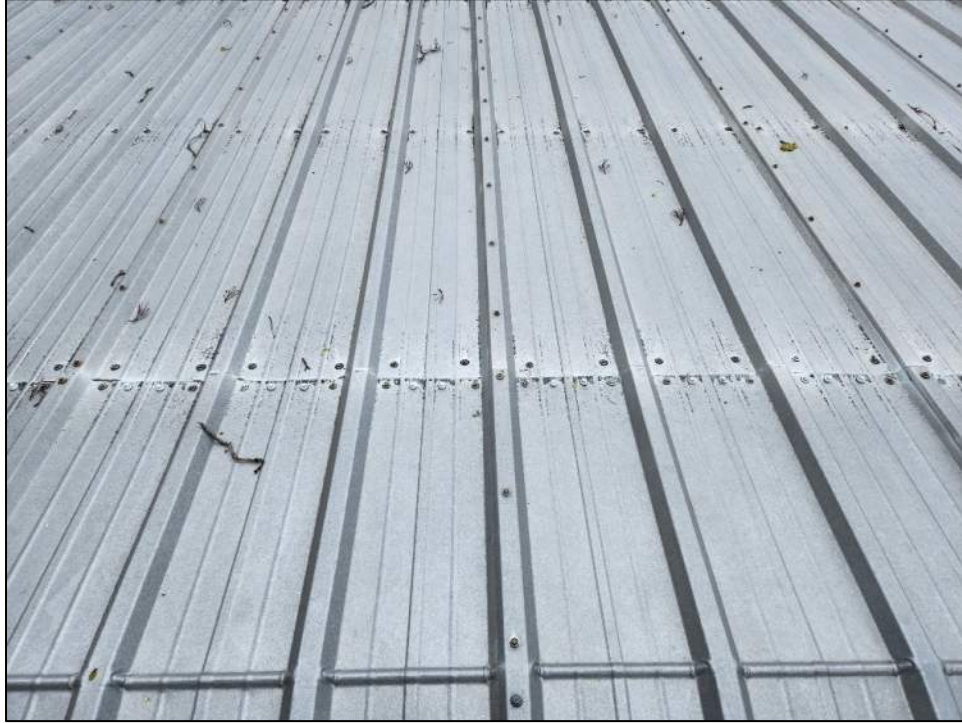
The Fire Station roof is a metal roof with exposed fasteners; several of the fasteners have been added over the years. It was reported that the roof leaks. A leaking roof often destroys the resistant value of insulation.

Roofing and Fasteners.

The roofing needs to be replaced. The roof insulation will likely need to be replaced as well. The minimum snow load required by the current building code for Plymouth, NH is 75 PSF. The minimum snow load required in New Hampshire at the time of the original building construction was approximately 30 PSF.

Removal and replacement of the roof will allow the roof purlins to be upgraded and additional insulation added. However, the remaining structural supports will be required to be reviewed and evaluated to determine the need for upgrades.

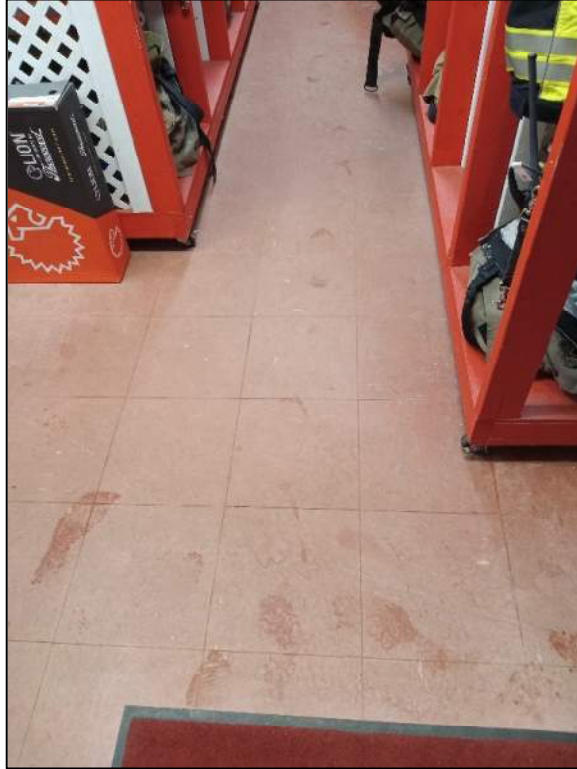
The flooring in the locker room is a tile of an unknown composition that is heavily worn and stained. It is not known whether the tile or associated mastics contain any Asbestos-Containing-Building Materials (ACBM). There is a wood baseboard in fair condition on all gypsum wallboard finishes only. There is no baseboard installed on the concrete masonry walls.

Worn and Stained Locker Room Flooring – Unknown Composition.

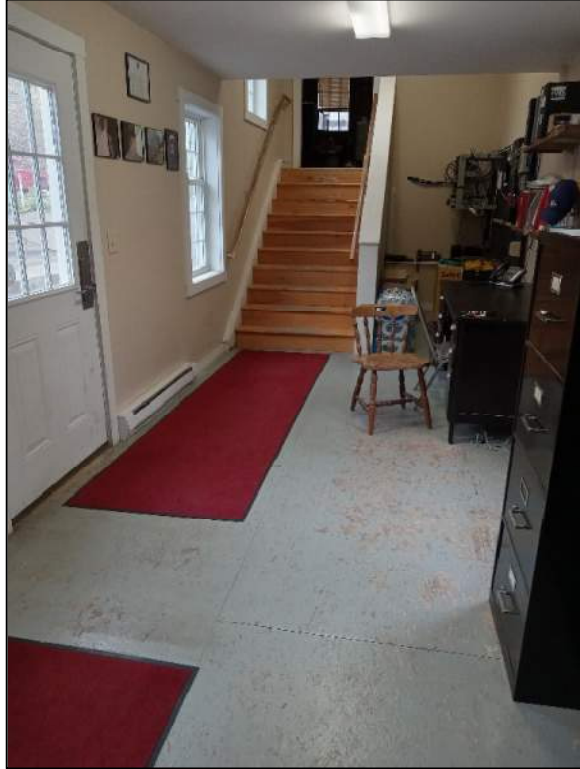
The flooring in the single-story addition to connect the original metal building to the adjacent residence is painted plywood. The paint is badly worn, particularly adjacent to the exterior entry doors. There is also a painted wood baseboard in good condition. There is a wood stair with stained wood treads and risers leading from the connector addition up to the first floor of the adjacent residence. The finish on the stair treads and some of the tread nosings are badly worn.

Worn Painted Plywood Flooring.

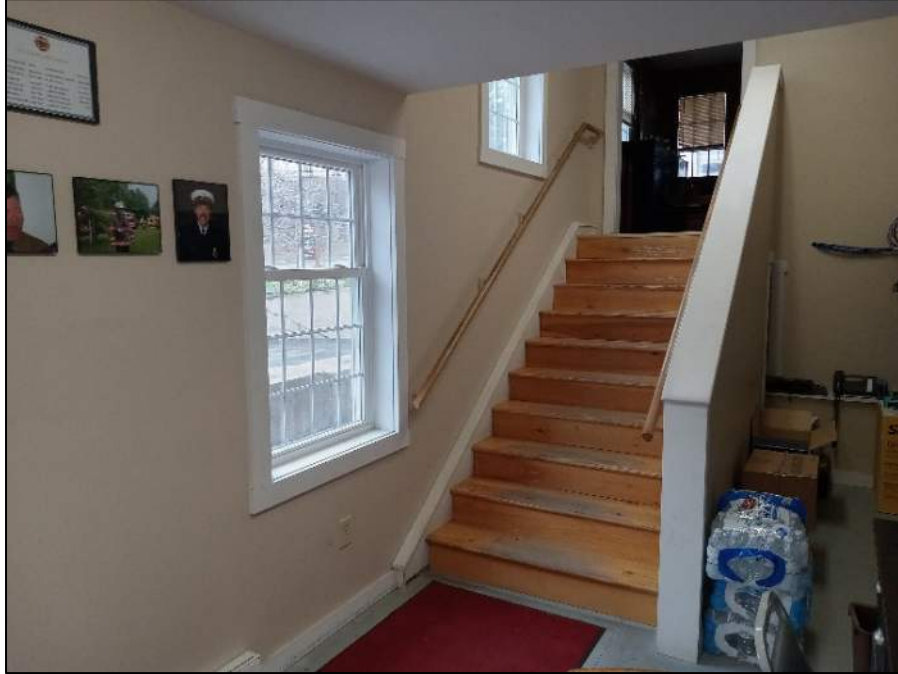
Worn Stained Wood Stair Treads and Nosing.

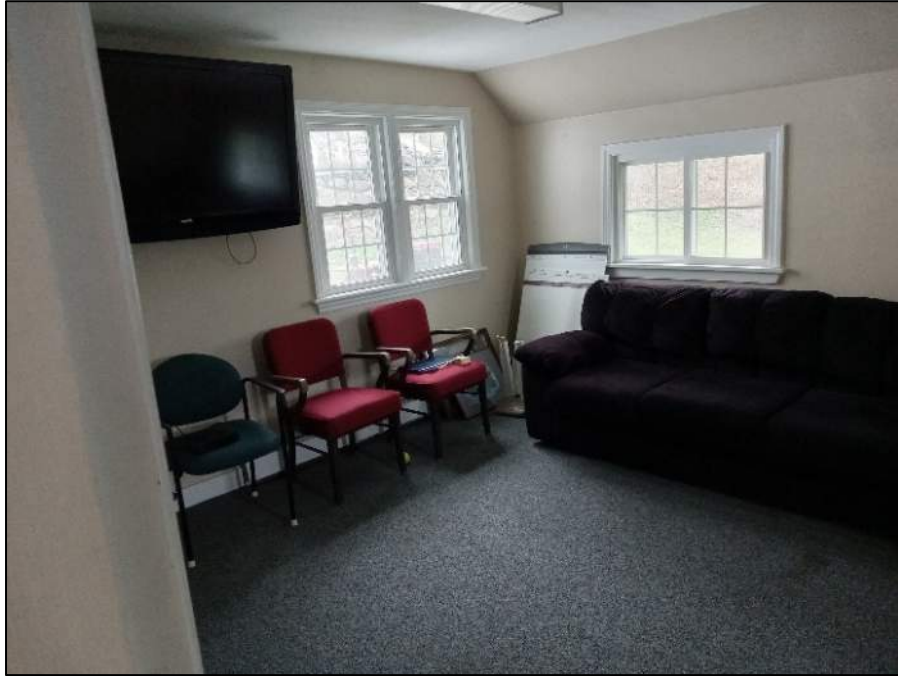
The flooring on the first floor in the adjacent residence consists primarily of laminated vinyl plank flooring with carpet located in the dayroom, conference/training room, front vestibule, and stair to the second floor and is in good condition. There is some staining on the carpet in the dayroom.

Stained Dayroom Carpet.

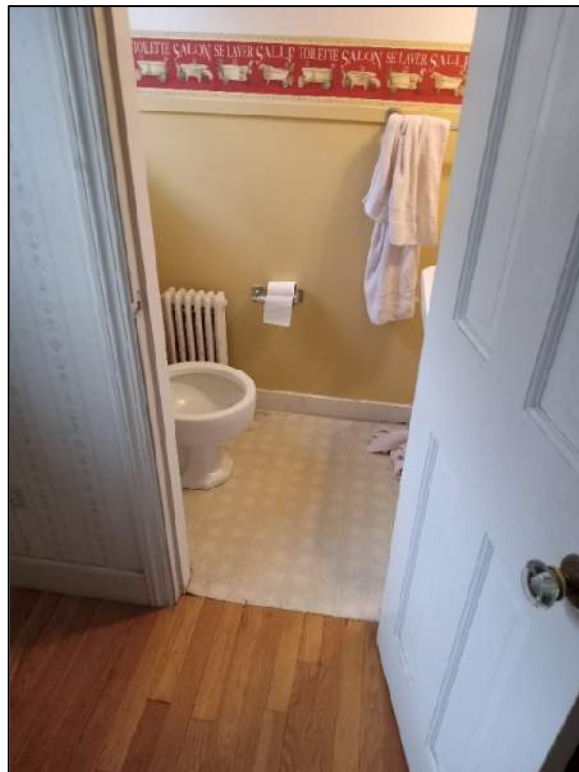
The flooring on the second floor is primarily wood strip flooring, very likely oak, and in good condition with a painted wood baseboard. The flooring in the bathrooms is sheet vinyl. There is a seam transition strip at the main second floor bathroom door at the intersection of the wood flooring with sheet vinyl. There is not a similar seam transition strip at the door of the second floor half-bath.

Transition Strip Between Dissimilar Floor Finish Surfaces.

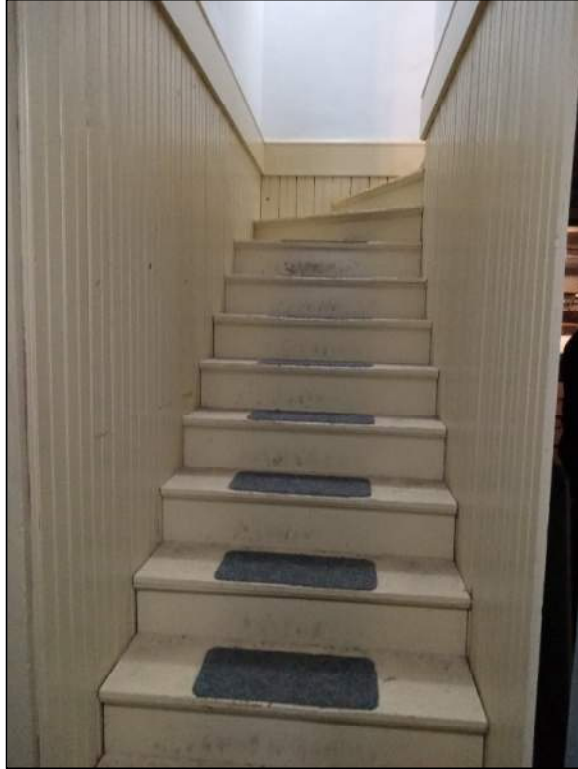
There is a painted wood stair from the first floor to the basement that is in fair condition. The nosing on some of the stair treads is badly worn.

Worn Treads and Nosing on Wood Stair to Basement.

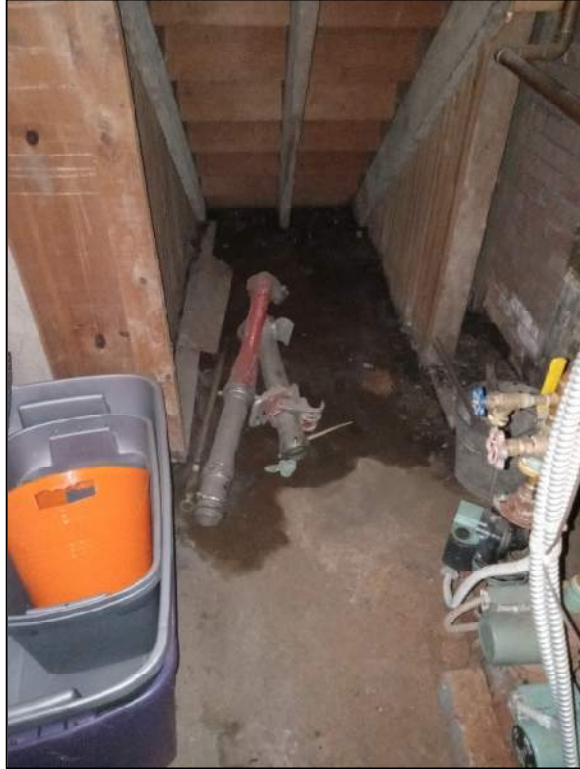
Water Infiltration thru Foundation Wall in the Basement.

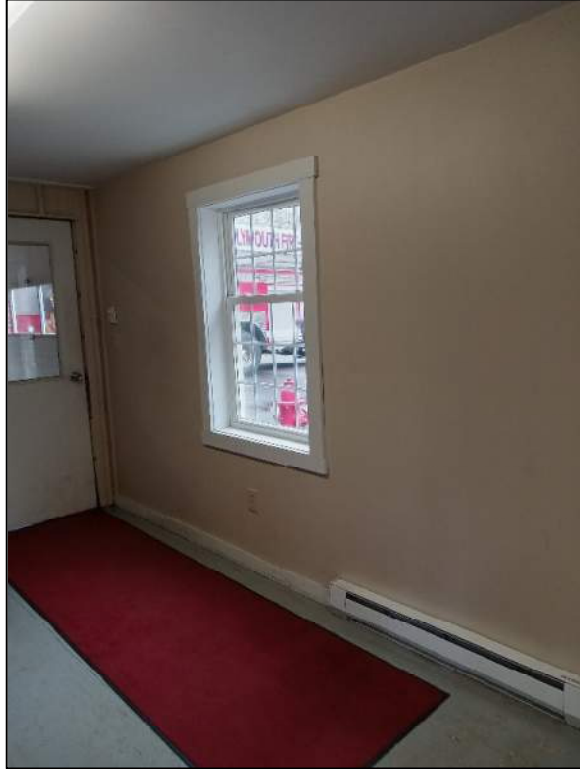
Non-Fire-Rated Wall Assembly Between Apparatus Bay and Addition to Residence.

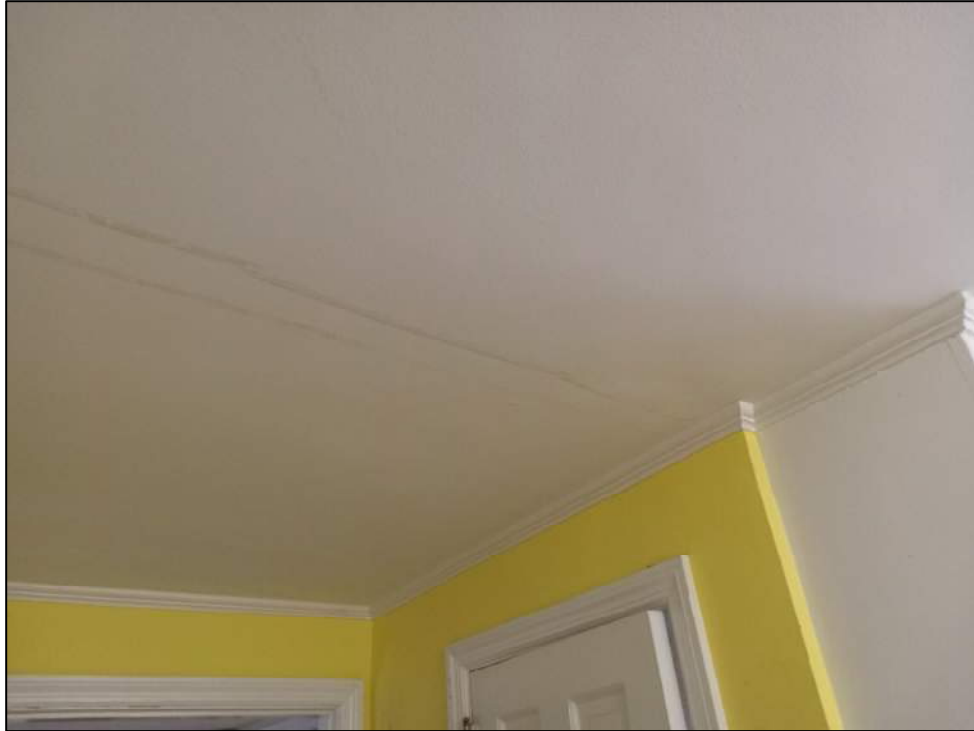
Patched Ceiling in Residence Kitchen from Removed Wall.

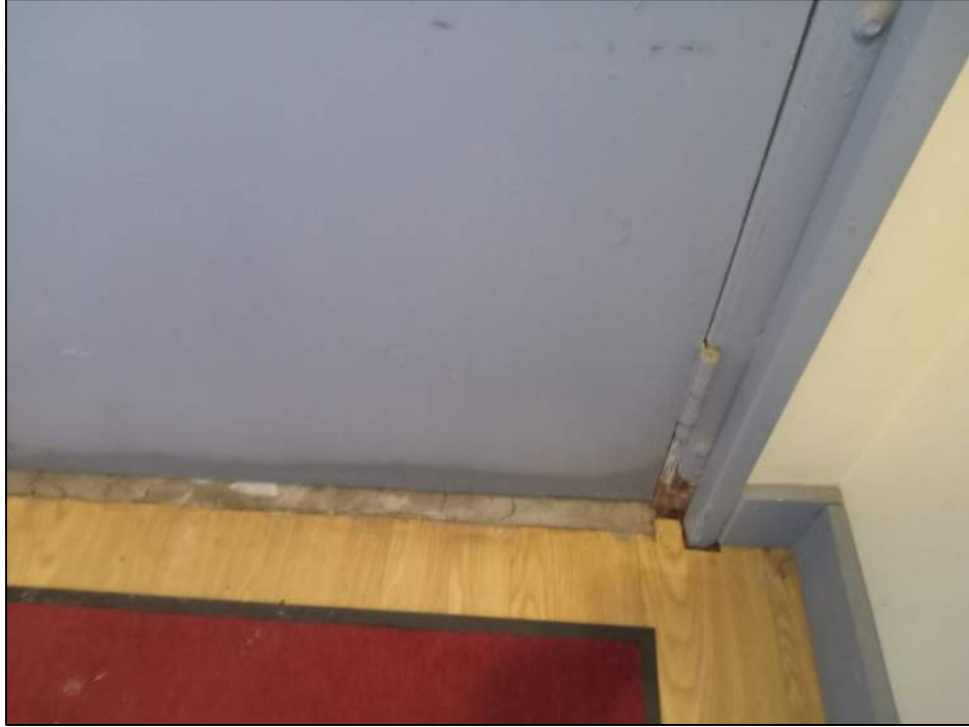
Rusted Exterior Door in Original Metal Building and Exposed Concrete.

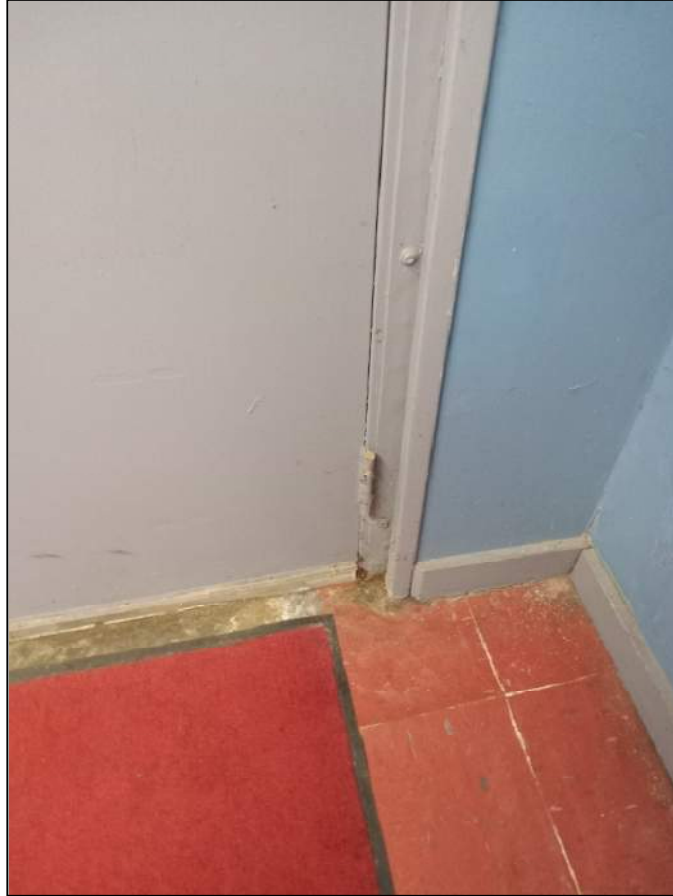
Exposed Concrete Between Finish Flooring and Exterior Door Threshold.

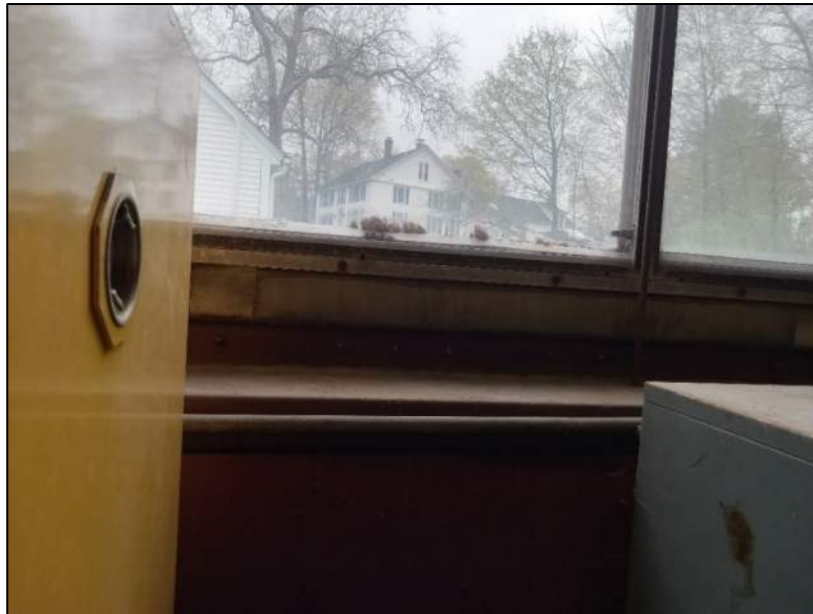
Single Glazed Metal Windows in Apparatus Bay.

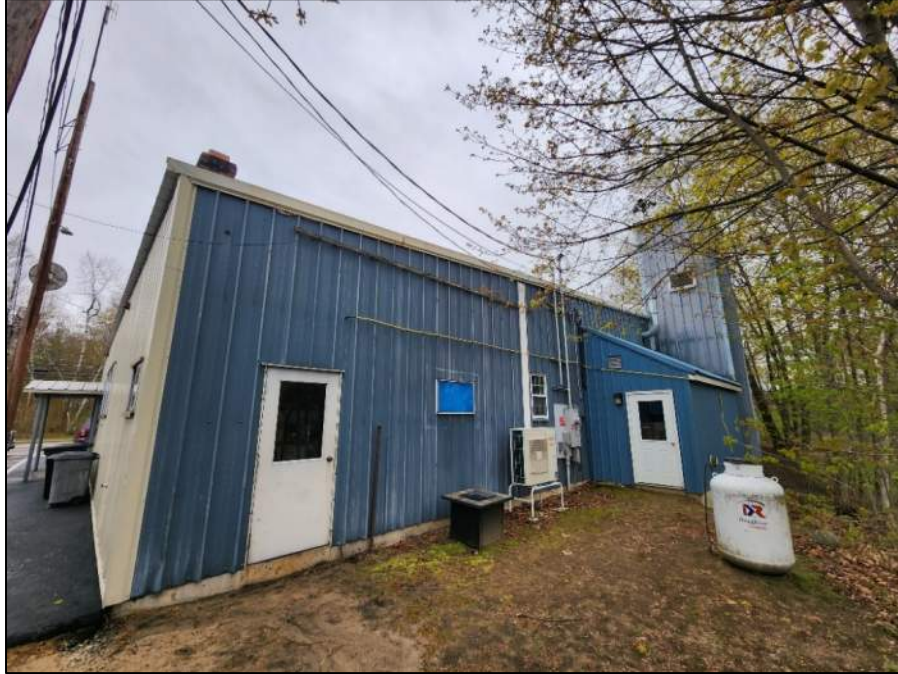
Former In-filled Exercise Room Window.

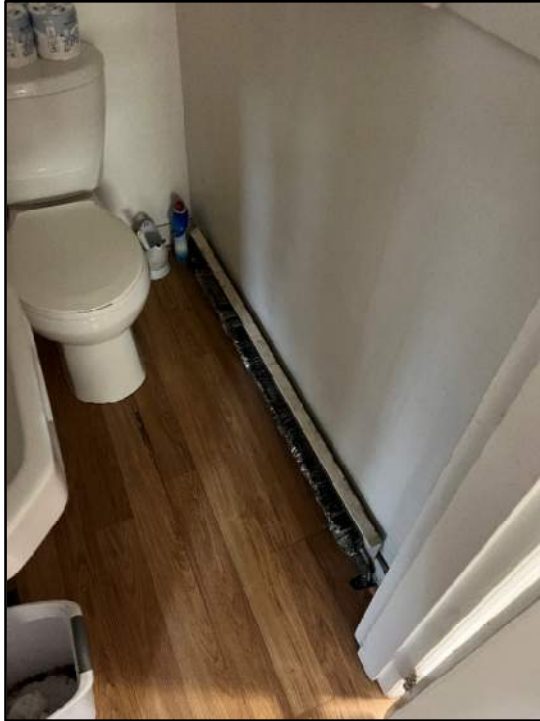
Damaged fin tube baseboard heater missing a protective cover in the residence house.
