# TOWN OF PLYMOUTH, NEW HAMPSHIRE

## PLYMOUTH POLICE DEPARTMENT FACILITY CONDITIONS ASSESSMENT

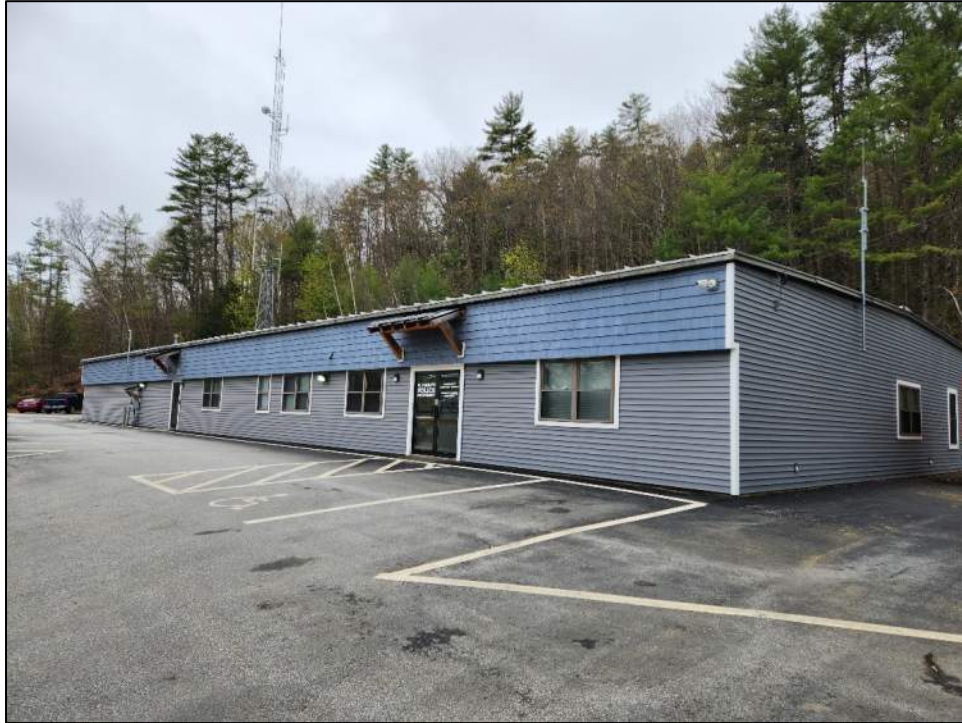
Front (East) Elevation.

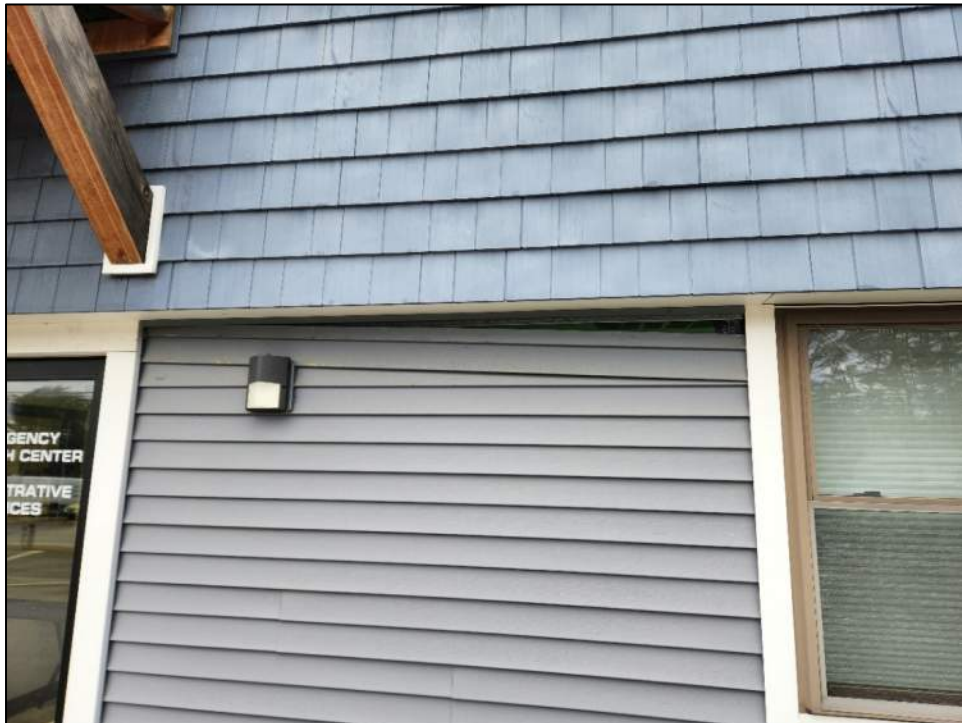
Damaged Siding Adjacent to Front Entry.

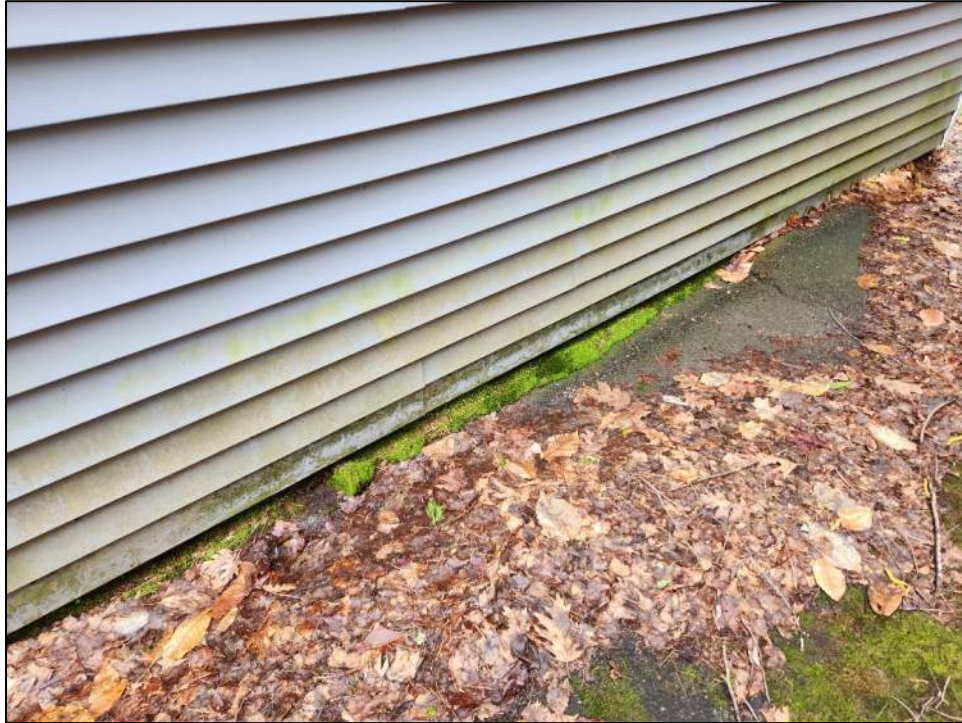
Moss Growing and Stained Siding along the Rear of the Building.

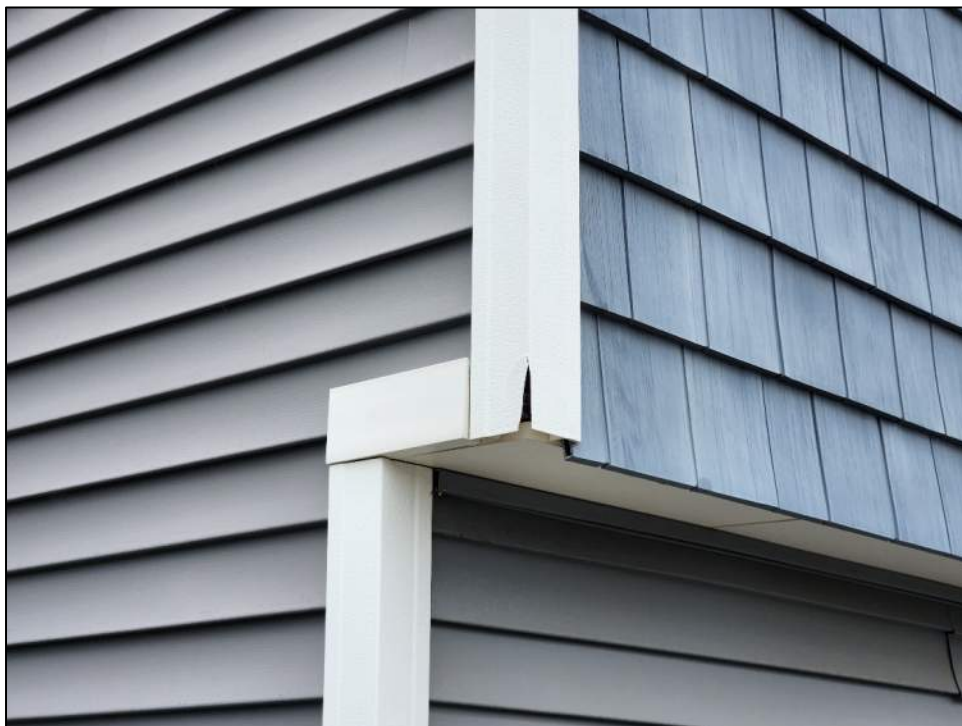
Cracked Corner Board.

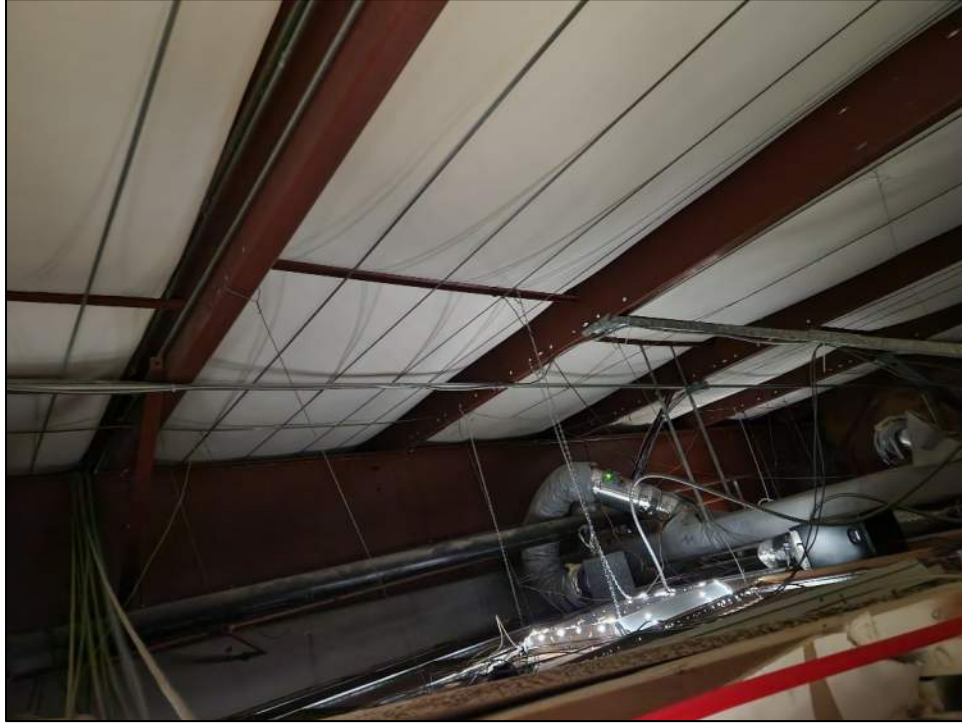
Pre-Engineered Metal Roof Purlins and Bent.

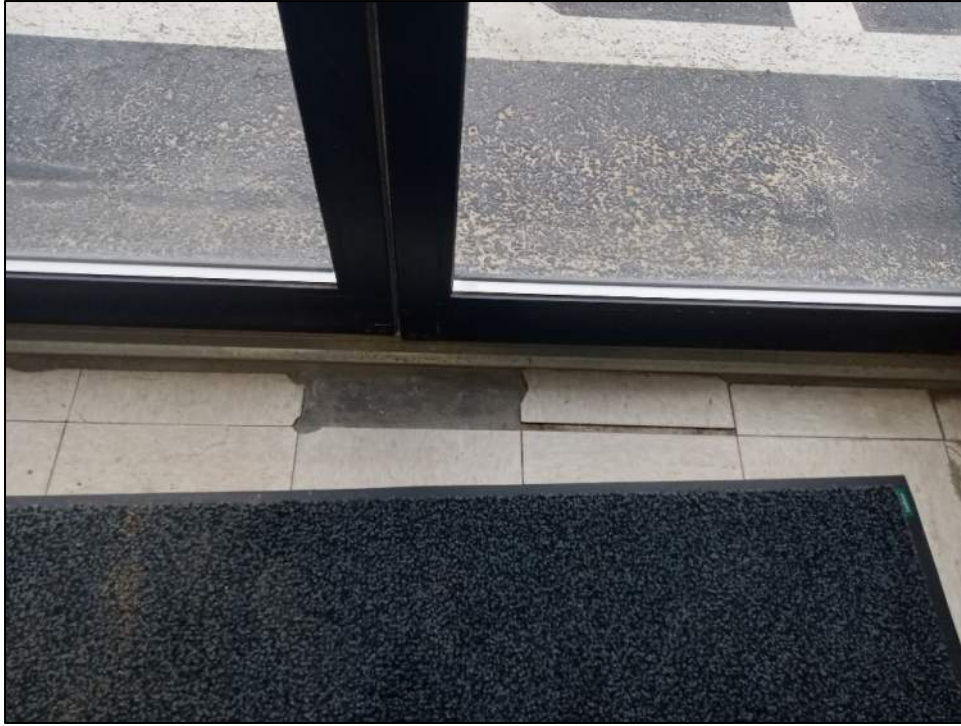
Entry Vestibule Flooring and Baseboard.

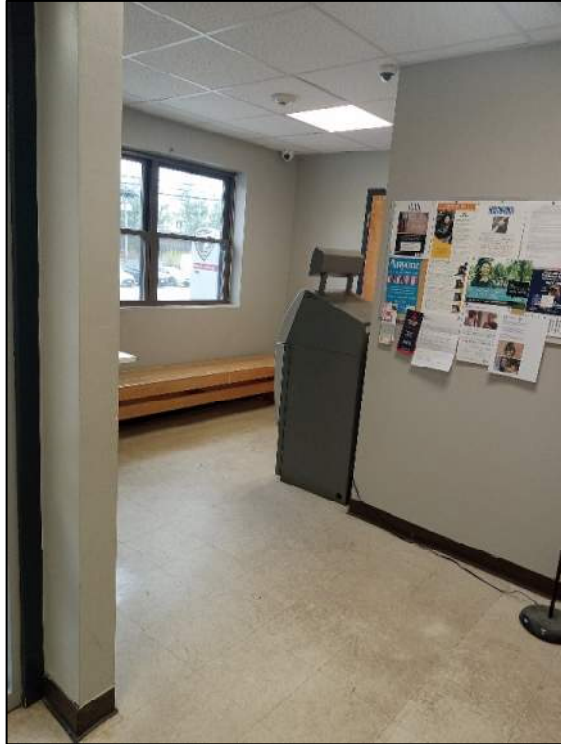
Heavily Worn Flooring Tiles in Public Waiting Area.

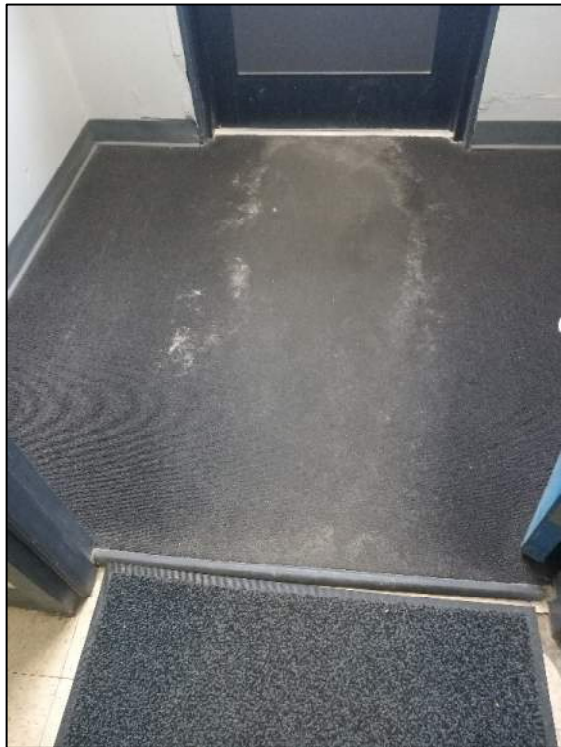
Heavily Worn Carpet Floor Finish in Exit Vestibule.

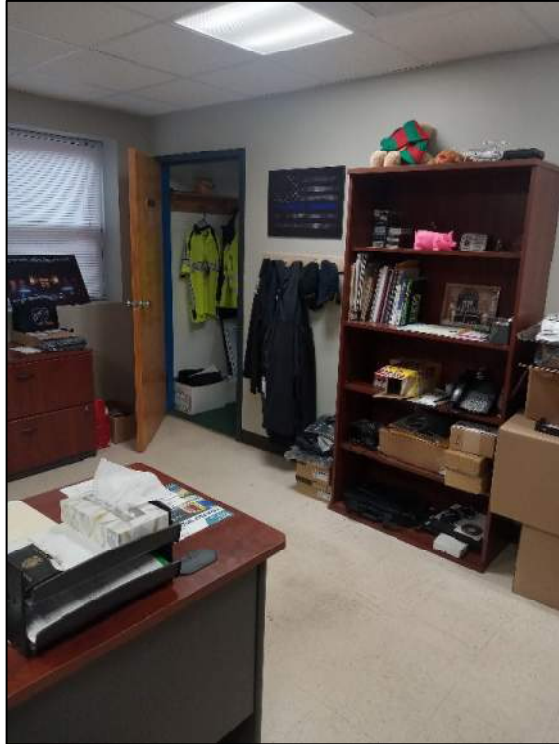
Worn and Stained Flooring Tile in Offices.

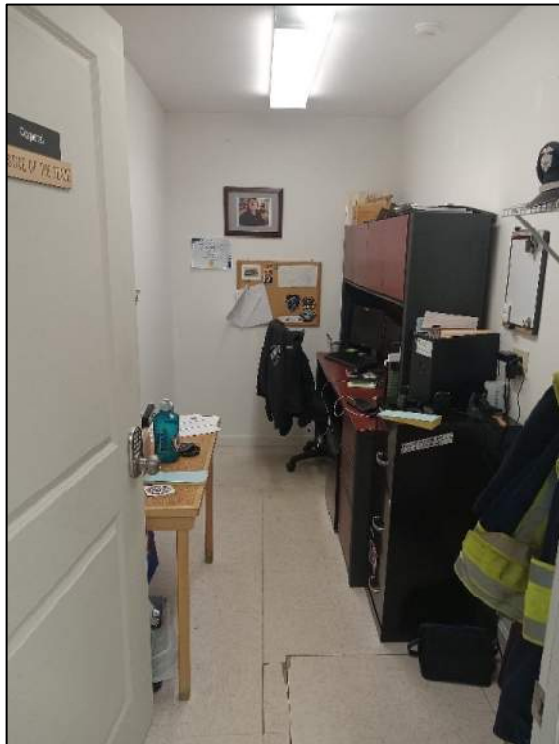
Patched Flooring Tiles.

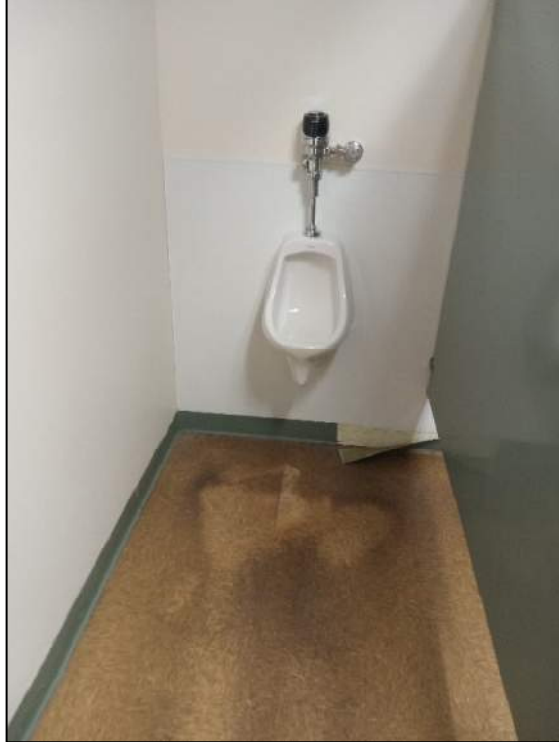
Heavily Worn Flooring Tile and Peeling Vinyl Baseboard in Men's Restroom.

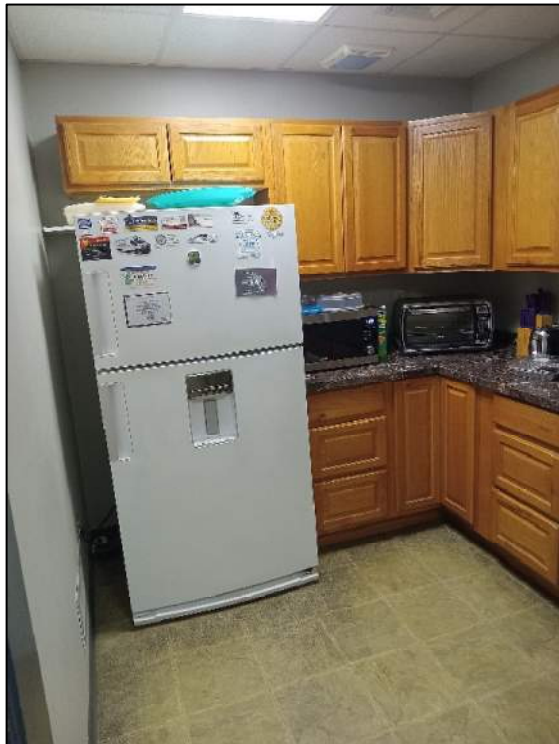
Heavily Worn Flooring Tile in Kitchenette.

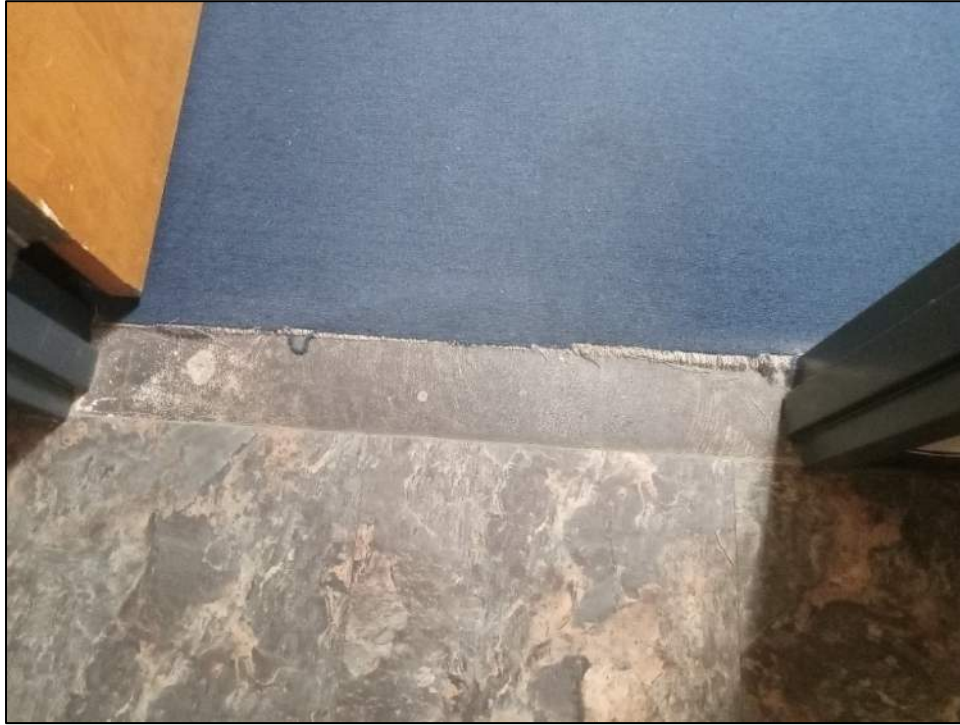
Exposed Concrete Floor Slab at Missing Flooring Transitions.

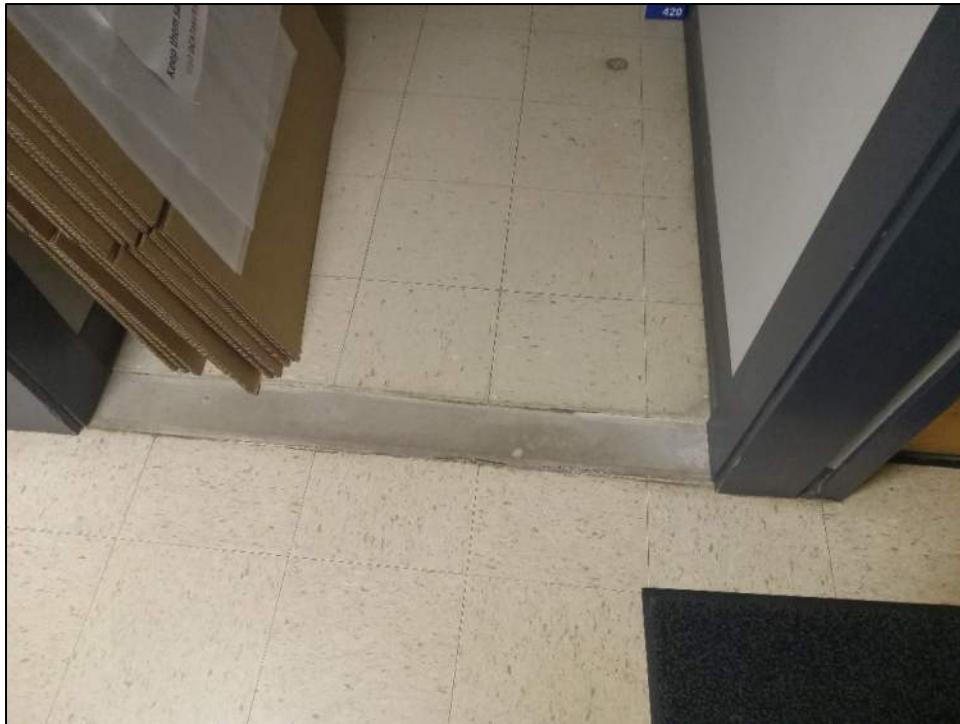
Exposed Concrete Floor Slab at Missing Flooring Transitions.

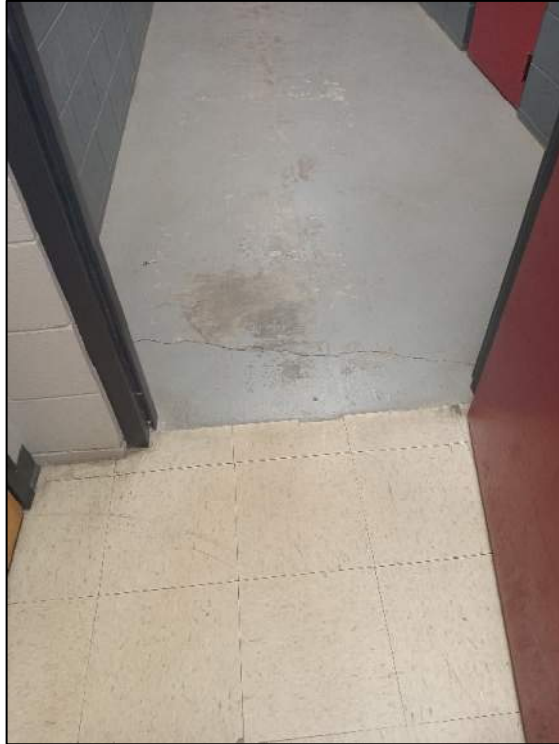
Missing Flooring Transition.

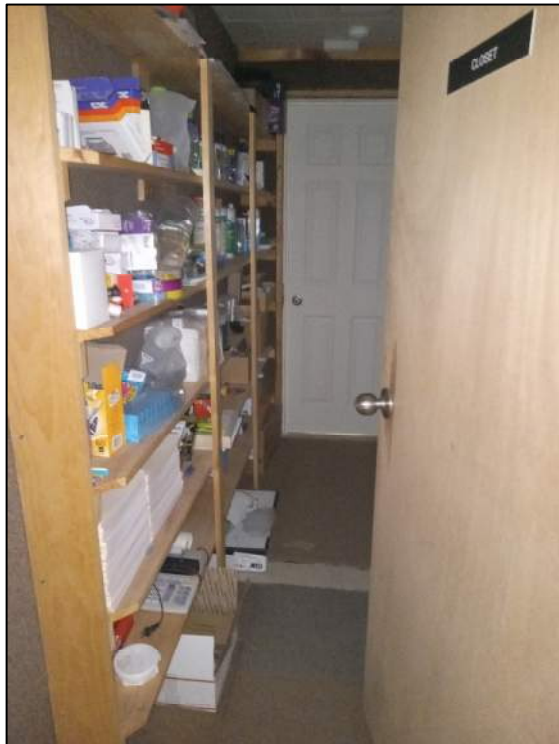
Not Permanent Floor Finish on Concrete Floor Slab in Closet.

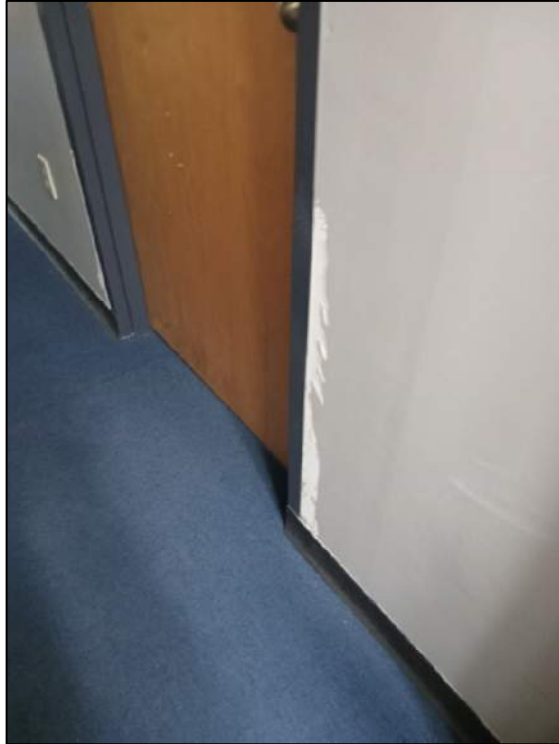
Damaged Wall Finish Surfaces Adjacent to Interview Room Door.

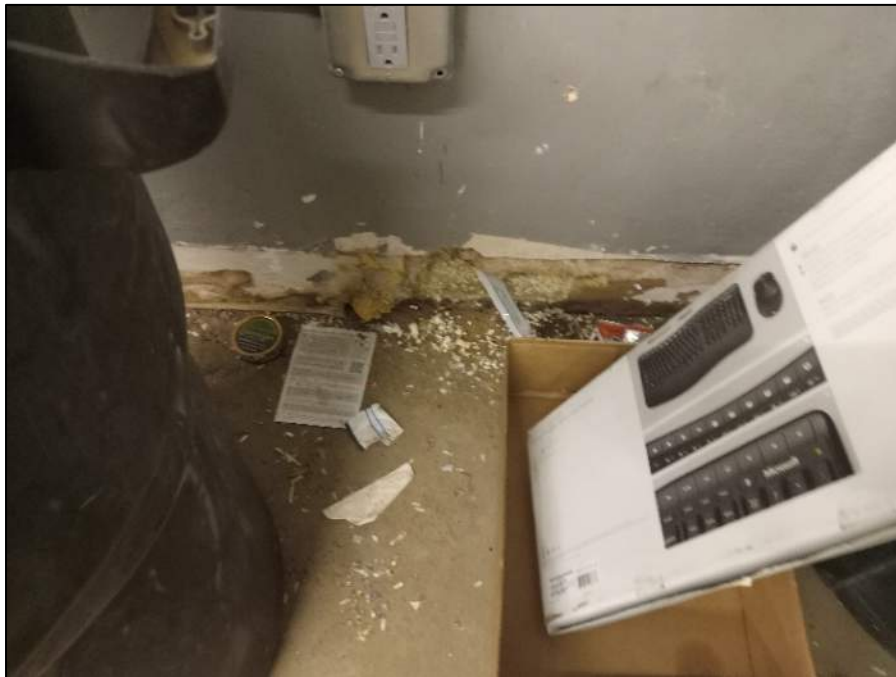
Damaged Gypsum Wallboard and Missing Baseboard at Bottom of Wall in Sallyport.

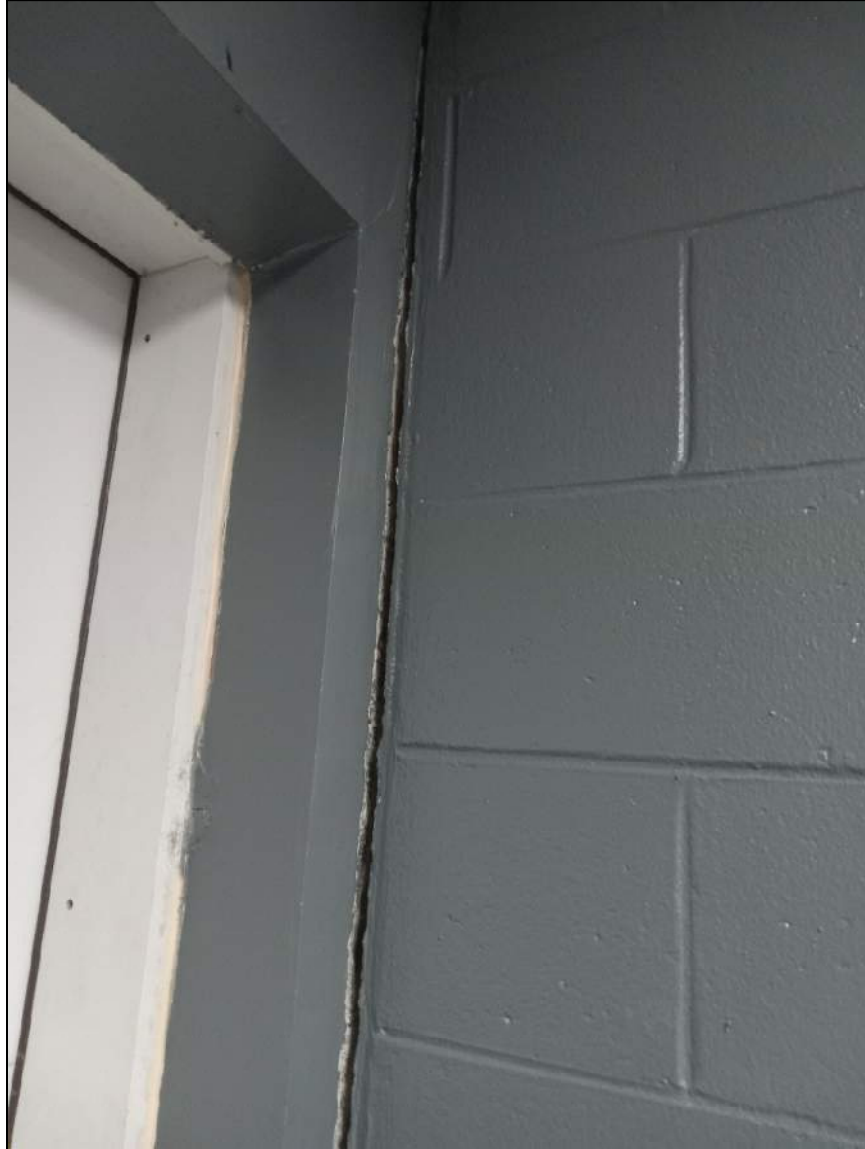
Concrete Masonry Wall Separating from Adjacent Concrete Wall at Armory.

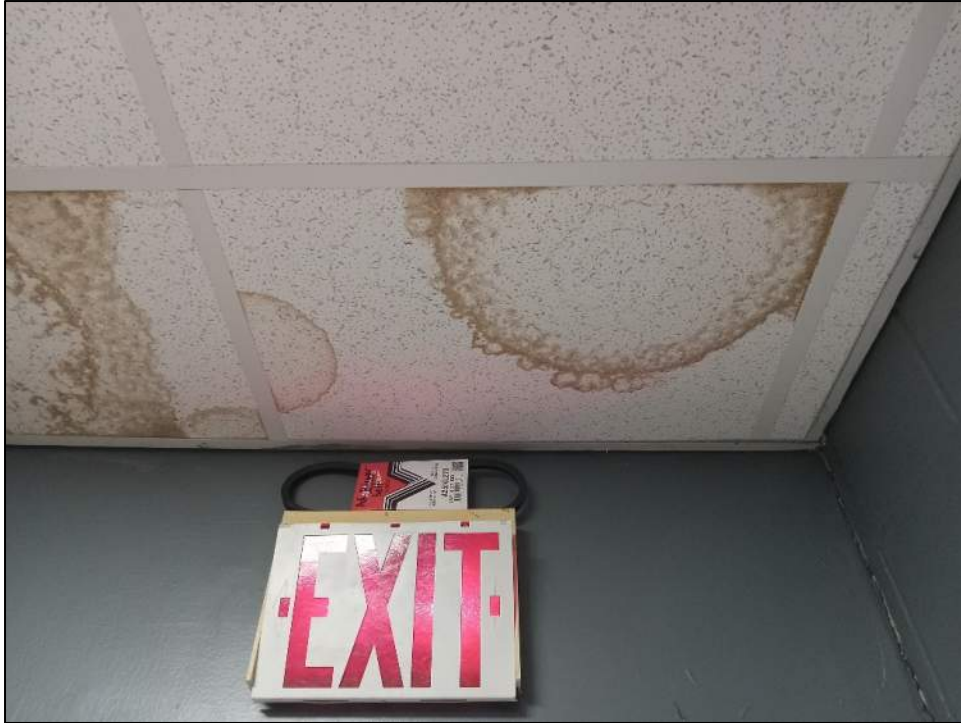
Water-Stained Ceiling Tiles.

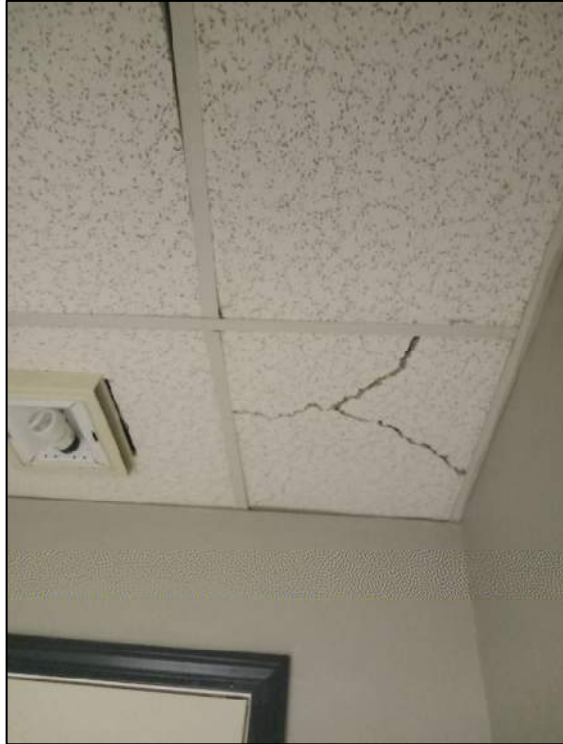
Broken Ceiling Tiles.

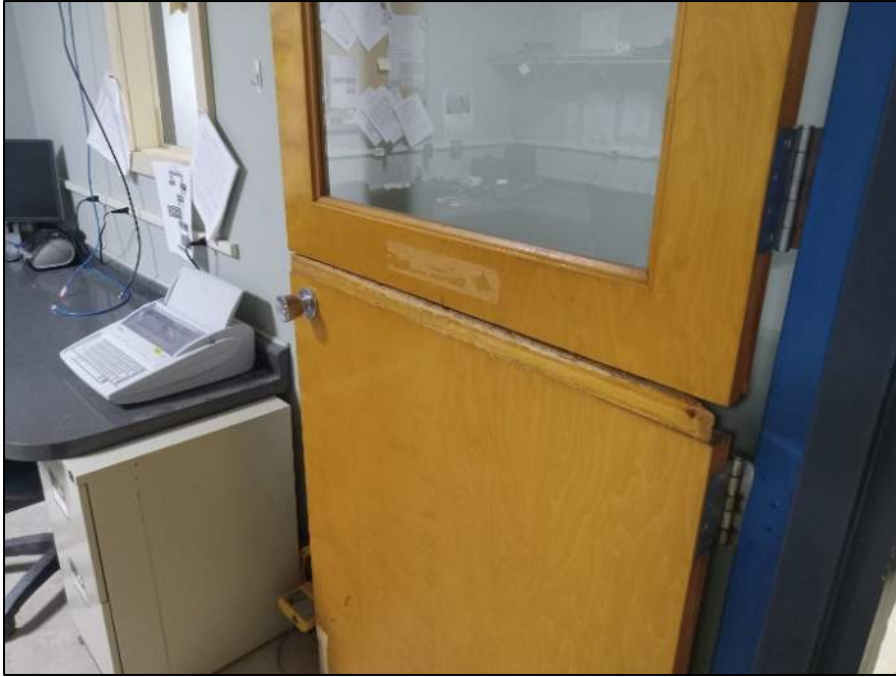
Damaged Dutch Door at State Police Office.

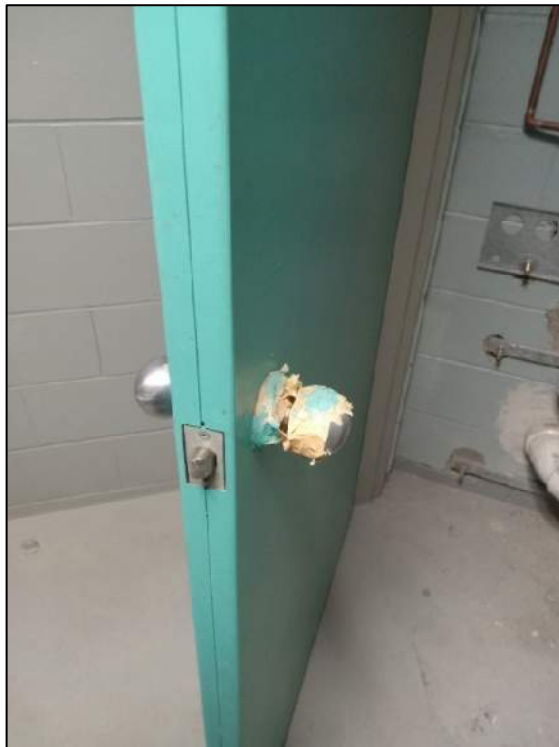
Damaged Doorknob at Cell Plumbing Access Closet.

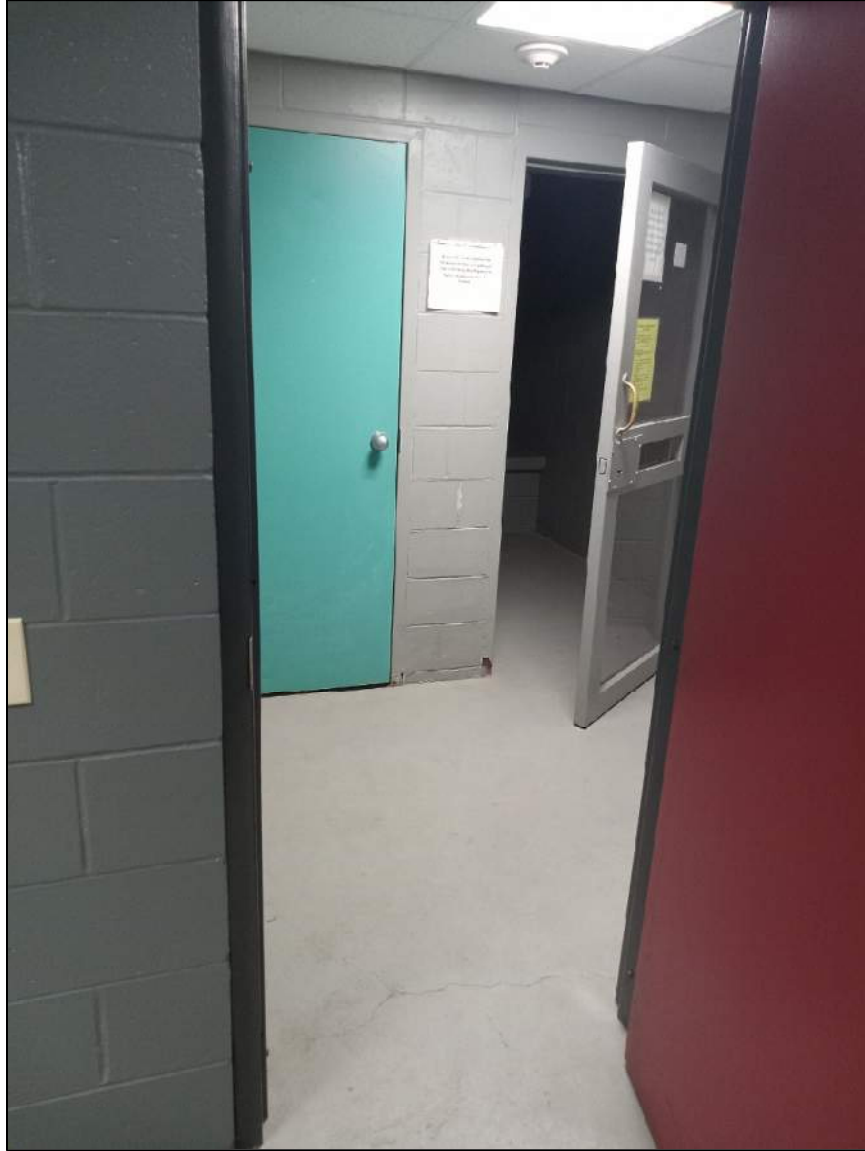
Damaged Metal Door Frame at Bottom of Juvenile Cell Door.

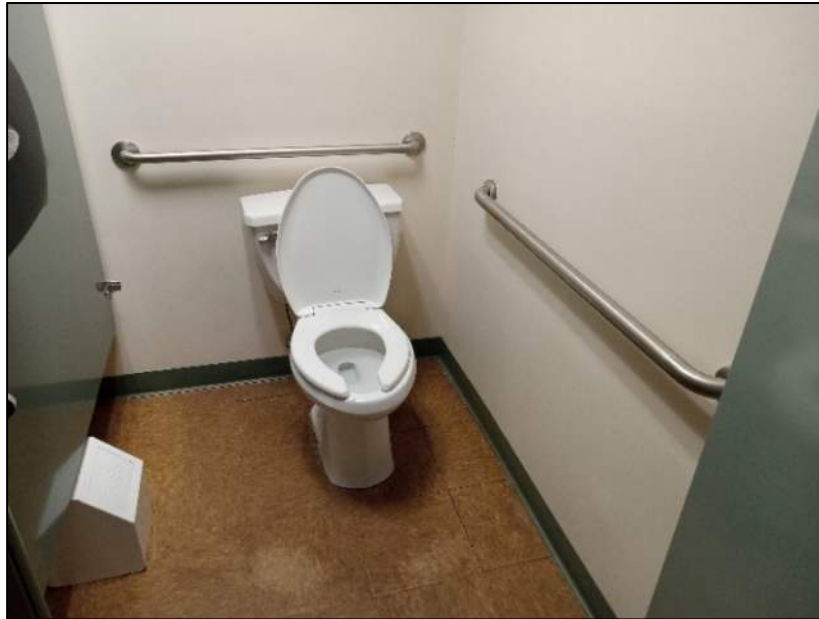
Missing Vertical Grab Bar at Side Wall of Accessible Toilet Stall in Women's Restroom.

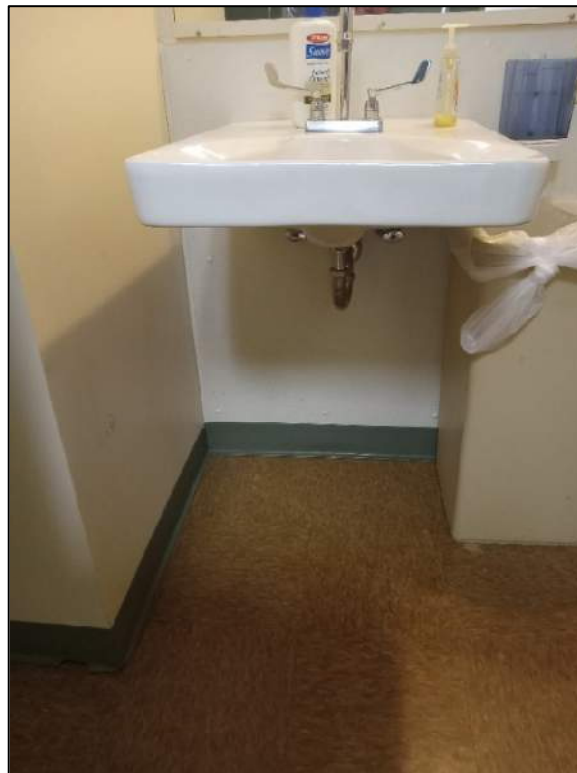
Missing Insulation at Accessible Sink Waste Pipe in Women's Restroom.

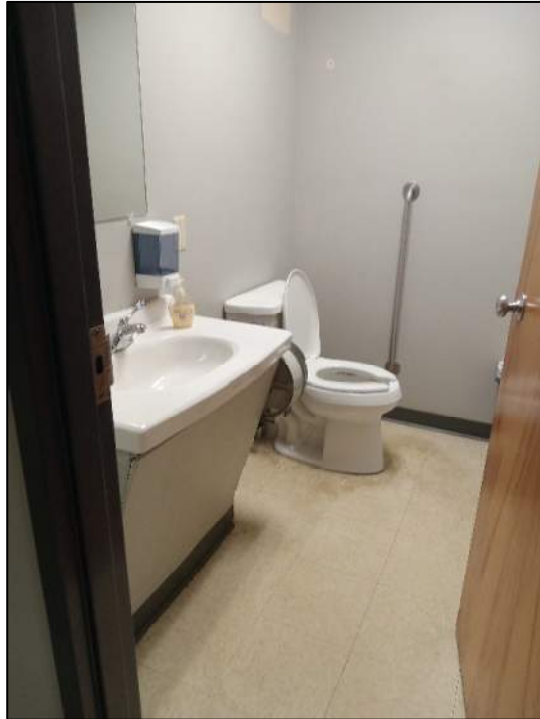
Missing Horizontal Grab Bars at Back Wall and Side Wall in Accessible Public Restroom.  
Insufficient Space Between Toilet and Sink for Wheelchair Maneuvering.

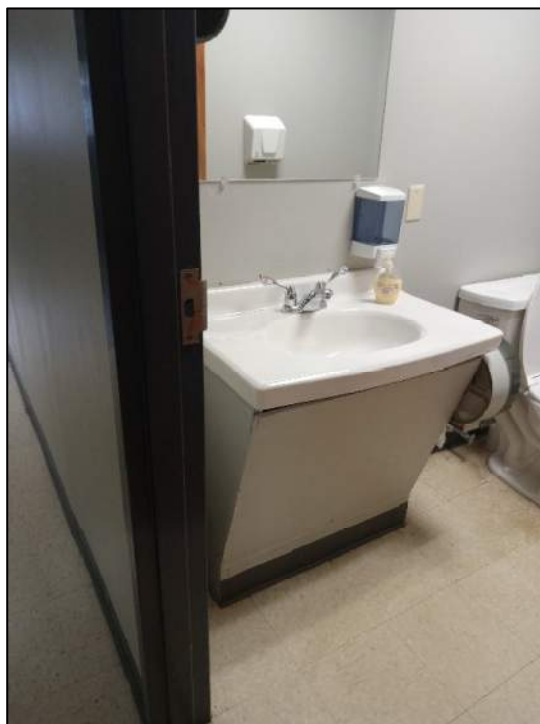
Mirror is Mounted too High Above the Floor.

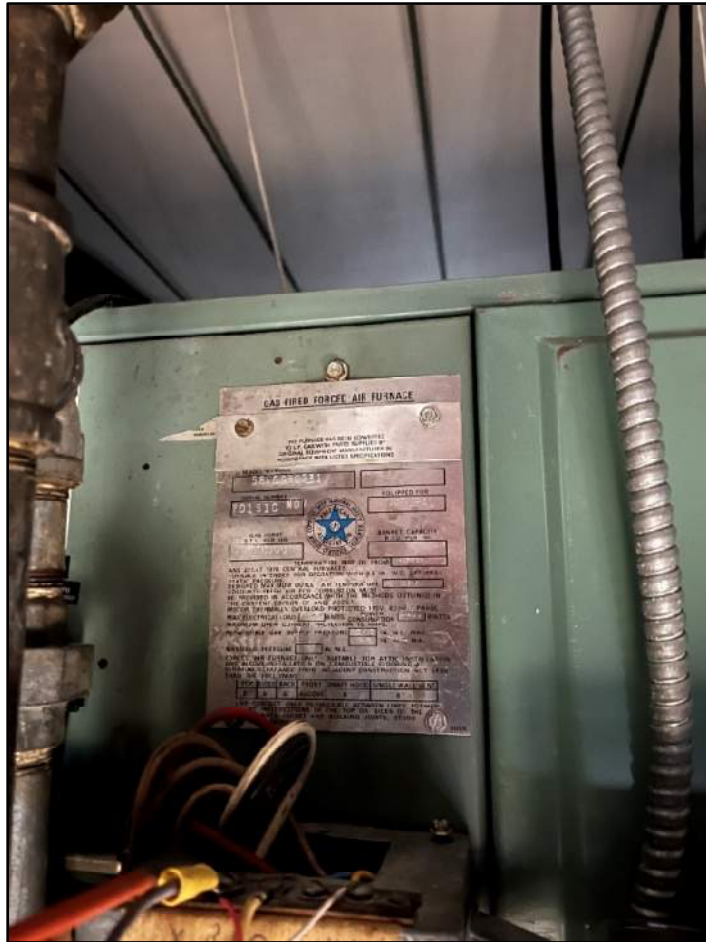
Existing gas-forced hot air furnace in the plenum space.
